# Appendix A Pavement Evaluation

## Airport Pavement Evaluation

### **Block Island Airport [Note: Photo not shown.]**

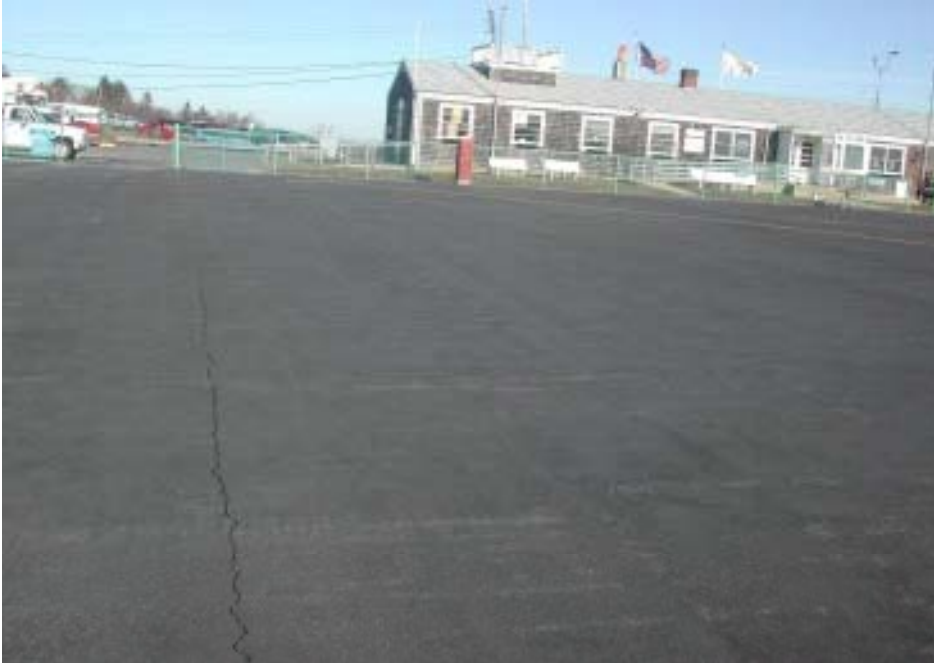
The terminal apron was separated into three sub-sections and the general condition of the pavement is fair. (See Figure A2-37)

Figure A2-37 Terminal Apron with Low to Moderate Severity Cracking

This area contained low severity longitudinal joint cracking in approximately 10%-20% of the area. (West portion of terminal apron)

This area contained moderate severity longitudinal joint cracking in approximately 40%-50% of the area. (Middle portion of terminal apron)

This area contained low severity longitudinal joint cracking in approximately 10%-20% of the area. There were a few low severity transverse cracks occurring. (East portion of terminal apron)

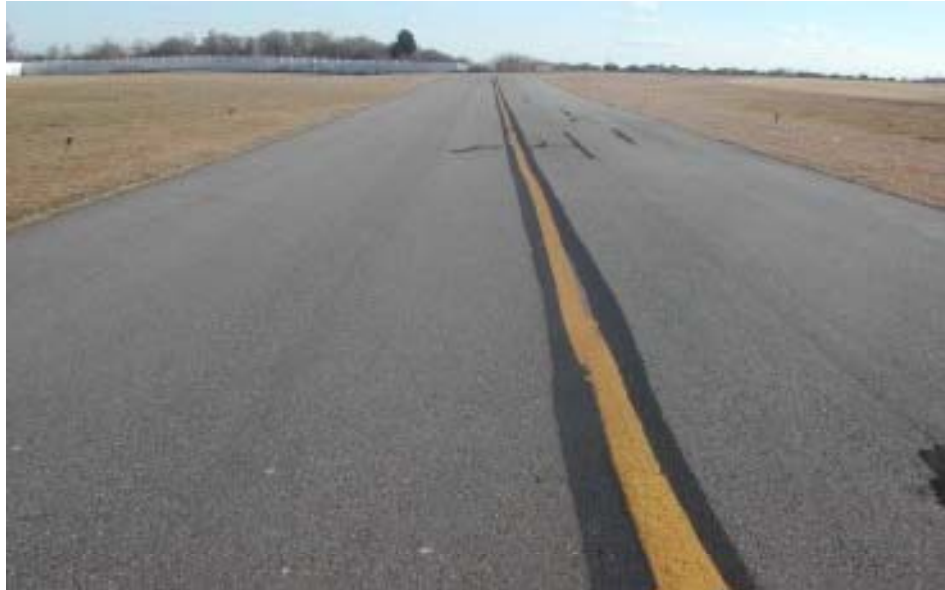
The taxiway contained a small amount of low severity random cracks. Crack repair is evident and appears to be fairly new. The pavement condition is good (See Figure A2-38)

Figure A2-38 Taxiway C with Low Severity Cracking

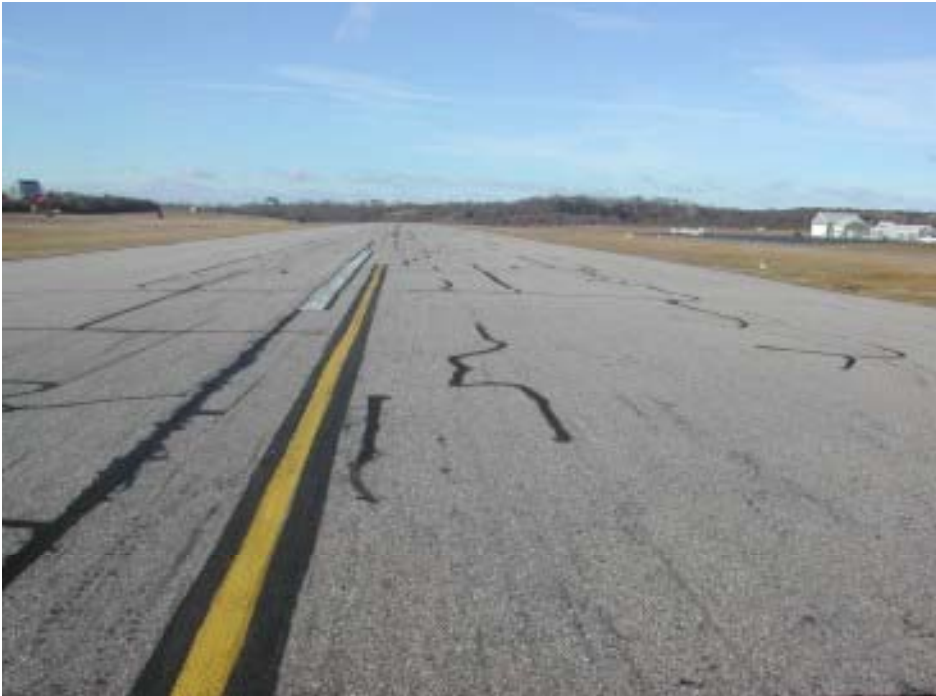
Uniform condition throughout, with high severity transverse and longitudinal cracking up to 2" wide. Crack repair is evident, however it does not appear to be recent. Pavement condition is fair. (See Figure A2-39)

Figure A2-39 Runway 10-28 with High Severity Cracking
