CHAPTER 4 Key Issues

**Airport
Master
Plan**

BLOCK
ISLAND
AIRPORT

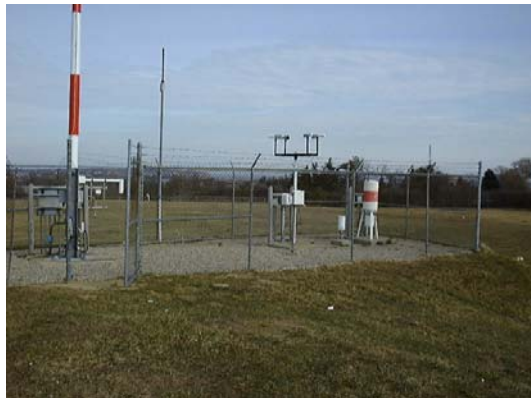
Figure 4-1 AWOS Weather Station

The existing airport weather station, located to the east of the paved parking lot immediately adjacent to the terminal (see Figure 4-1), provides vital weather information to pilots and others. Given its location, early questions were raised as to whether it would constitute an “immoveable

object” where the terminal and/or parking would have to be sited around it or in relation to the station.

It was presumed that the weather station could indeed be relocated elsewhere on the airport and planning for the airport terminal proceeded accordingly. In the preferred terminal area layout plan (Chapter 6), the weather station remains in its present location.
